BEDFORD 151/151
NH114 over BOWMAN BROOK

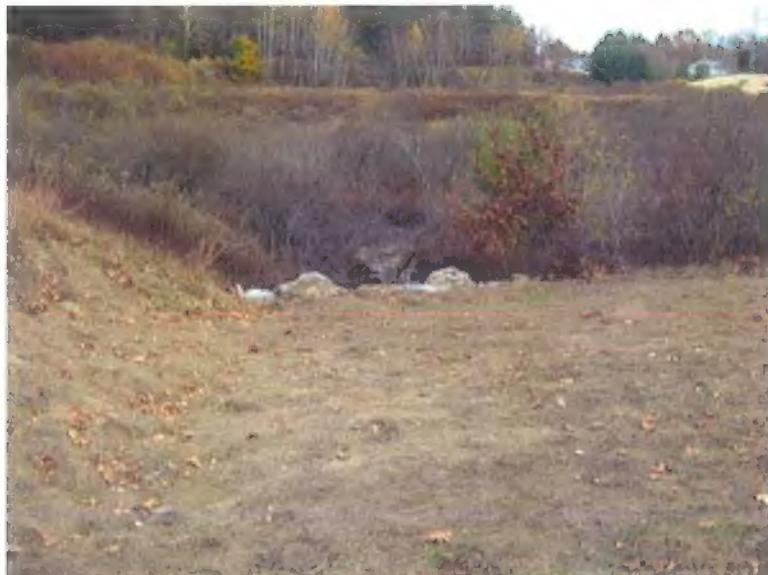
D153 71

**BANK EROSION REPAIRED
AT EAST OUTLET. SRL.**

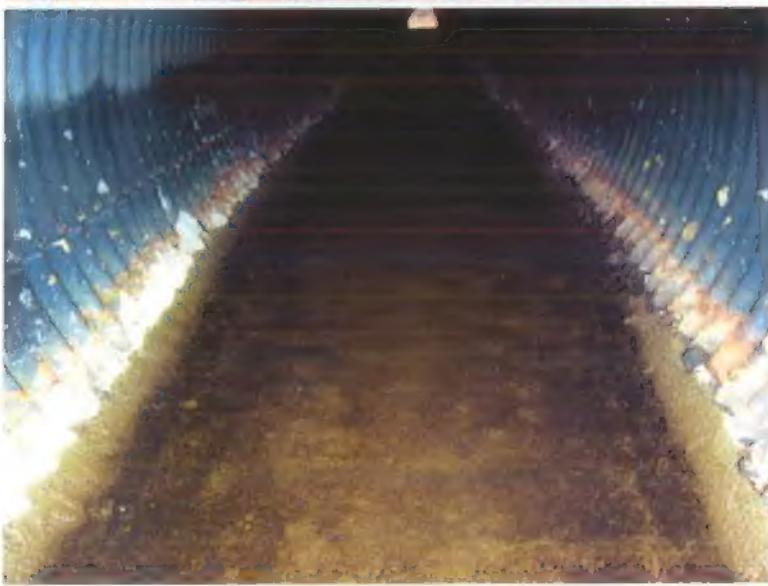
D153 73

**VIEW OF REPAIRED
INVERT AT EAST. SRL.**

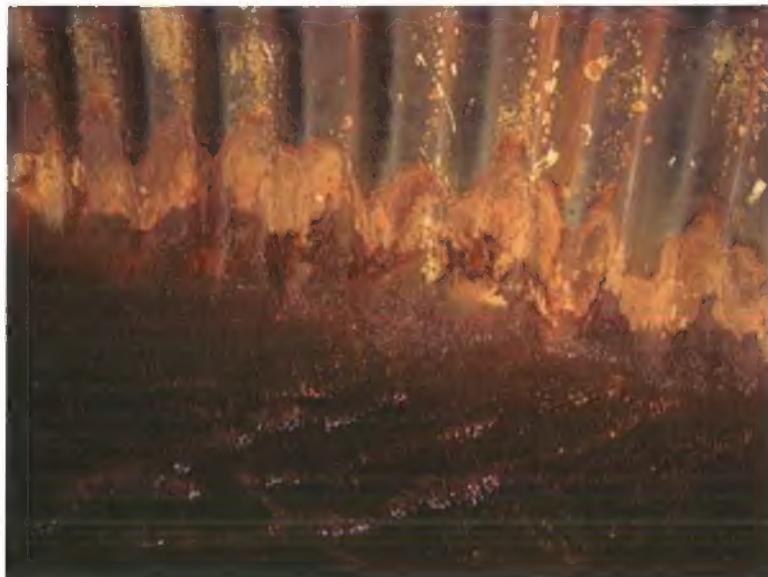
D175 30

RADIUS HOLED ABOVE
REPAIRED AREA,
NORTHEAST. (SRL)

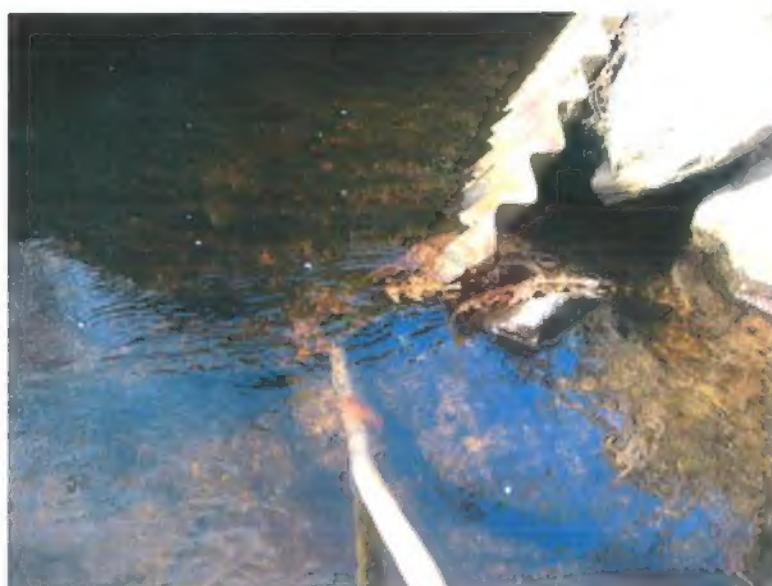
D079 10

VOIDED AT OUTLET.
(STATE RED LIST.)

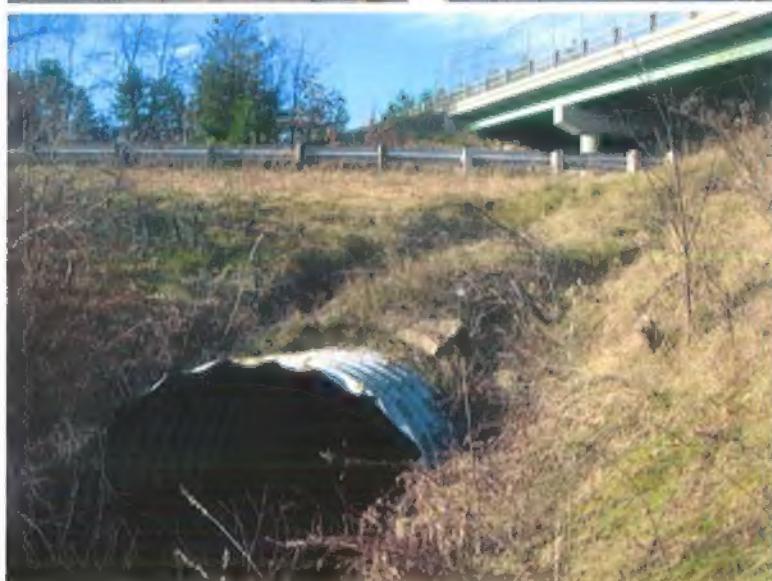
D079 11

EROSION OVER PIPE
DOWNSTREAM. (STATE
RED LIST.)

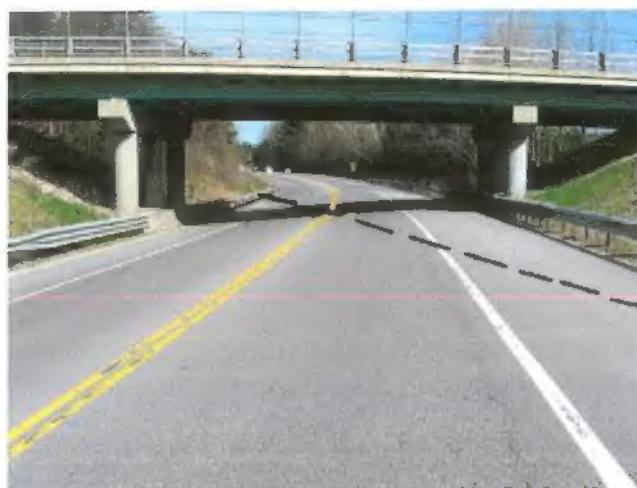
D032 25

SOUTH APPROACH. RUNS
DIAGONALLY UNDER IB-C
BRIDGE. ADDED TO THE
INVENTORY & TO THE STATE
RED LIST.

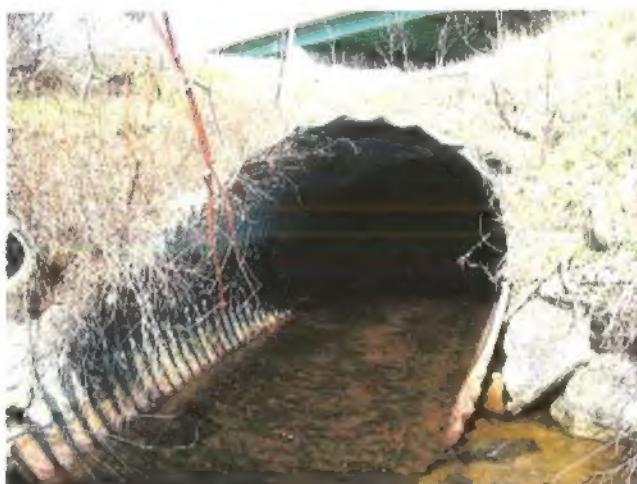
D032 23

EAST ELEVATION. EROSION
AT SLOPE. ADDED TO THE
INVENTORY & TO THE STATE
RED LIST.

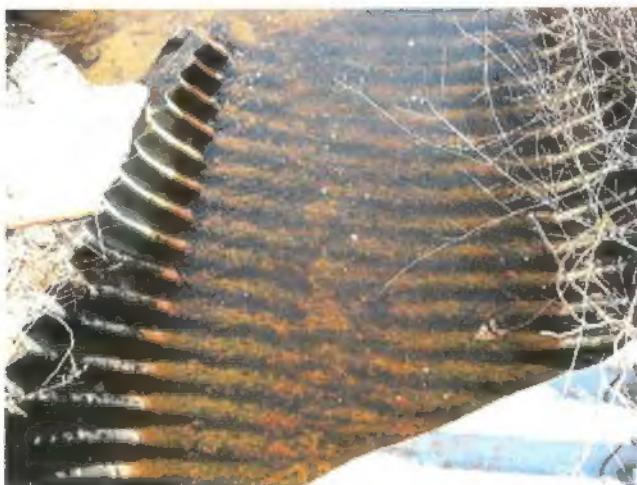
D032 22

INVERT HOLED AT EAST.
ADDED TO THE INVENTORY &
TO THE STATE RED LIST.
